Decontamination and Decommissioning of the Organic Moderated Reactor Experiment Facility (OMRE)

Robert E. Hine

September 1980

EG&G Idaho, Inc. Idaho Falls, Idaho 83415

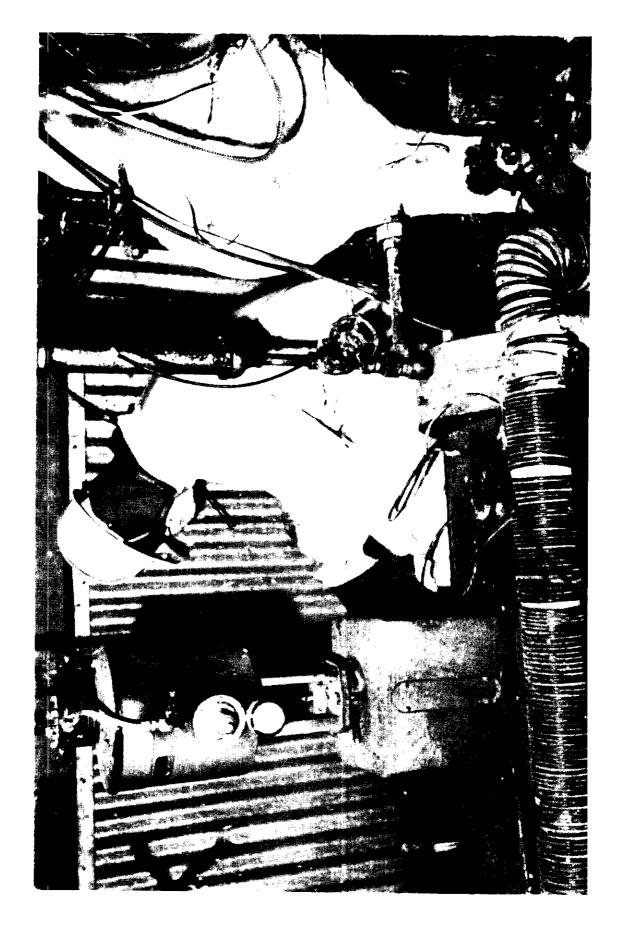
Most of the facility piping was covered with asbestos. Removal of the piping required cutting the pipes and this, in turn, required removing some of the asbestos covering. The hazard of asbestos inhalation was avoided by requiring the workers to wear respiratory masks and by placing a high-efficiency particulate (HEPA) filtered industrial vacuum at the point of any asbestos cutting. In addition, the workers wore lapel air samplers that were periodically examined to assess the vacuum system effectiveness. These periodic examinations disclosed that there was no personnel exposure to asbestos particulates greater than 5 micro-meters in length and the particulate density was less than 2 fibers per cm³ (OSHA¹⁴ allowables). Figure 27 shows two workers removing asbestos insulation from a pipe before cutting.

Figure 27. Removing asbestos insulation from piping prior to cutting pipe.

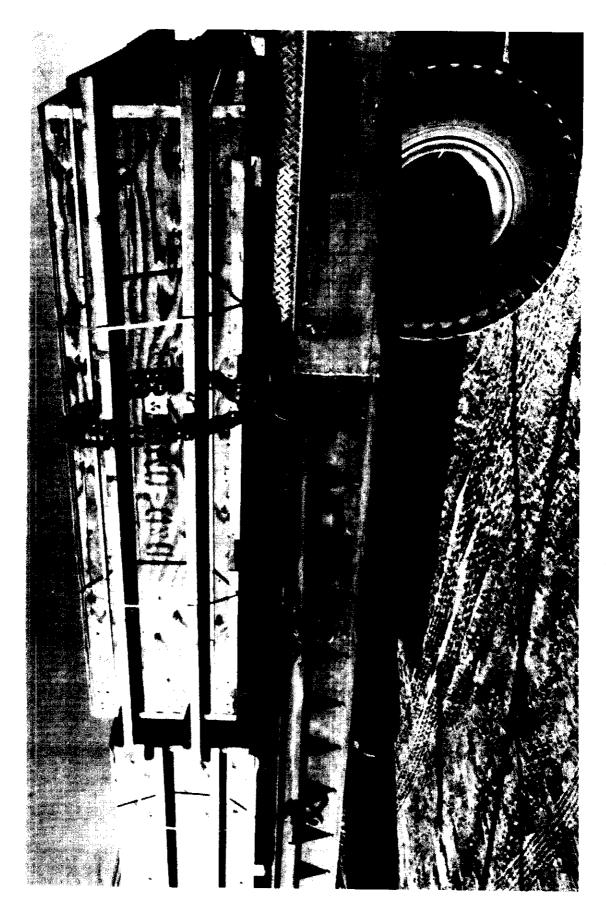
In October 1978, a shipment of radioactive soil enroute from OMRE to RWMC sprung a leak and spilled an estimated 0.5 ft³ of soil. An investigation of this incident was conducted by a specially appointed committee, and a report 16 was issued with recommendations aimed at preventing future such incidents. In summary, one 2 x 4 x 8 ft plywood box (about 5,500 lbs) was transported with supports under the ends only and the weight of the soil opened a bottom seam of the box. Figure 72 shows the improperly loaded box with the unsupported center and a tie-down chain aggravating the situation. Figure 73 shows one box on the verge of opening the bottom seam, and Figure 74 is a close-up view of the opened seam. Some soil was collected from the truck bed, and radiation was measured at 5,000 cpm. The personnel involved, the truck tires, and roadway were monitored and no detectable radiation was found. As a result of this incident the box design was strengthened and specific instructions regarding shipping and tie-down were emphasized.

Figure 73. Soil box skids separating because support was inadequate.

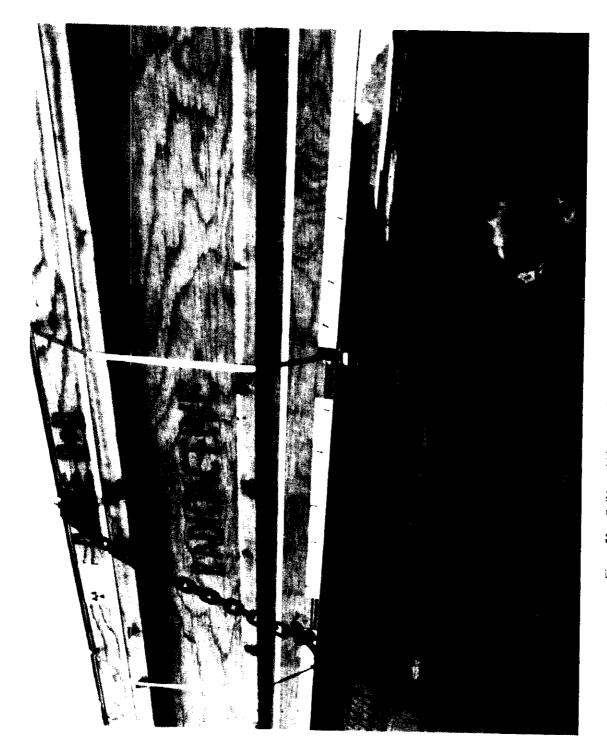
Figure 74. Ruptured bottom seam of soil box.
